MIT508 - Sound issue.

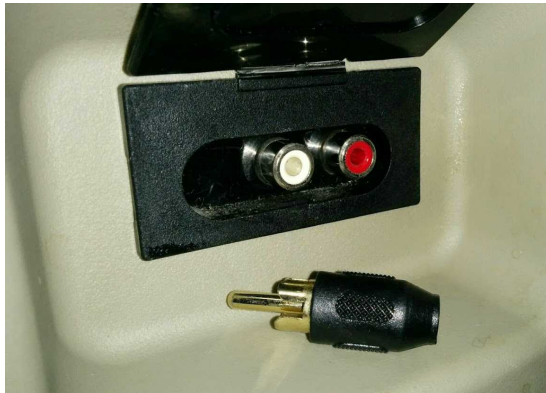
Factory RCA port with nothing connected to it causes the two ports to be in MONO mode which will cause GROM to not play properly for sound reproduction. A remedy to the issue is to have something plugged into one of side of the factory Auxiliary RCA input. This will trigger the RCA inputs back to Stereo signal allowing GROM to reproduce sound properly to the stereo AUX mode.

1. Locate RCA cable scrape or one you do not care about and cut wire off end of it. We will only use the RCA connector end of it.
